Investigation of Super Absorbent Polymer (SAP) Migration in Commercial Aviation Turbine Fuels

Edition 1

IATA Filter Monitor Task Force

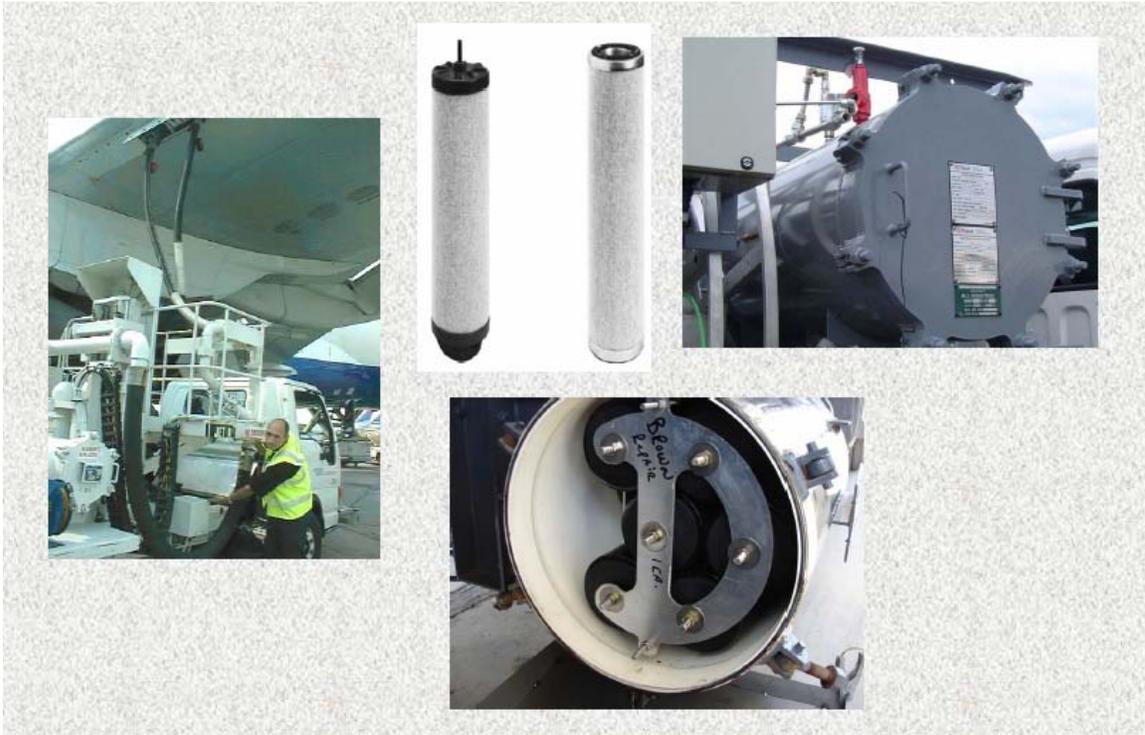
Figure 3-2 Water Absorbing Media Locations; Picture: Courtesy Continental Airlines

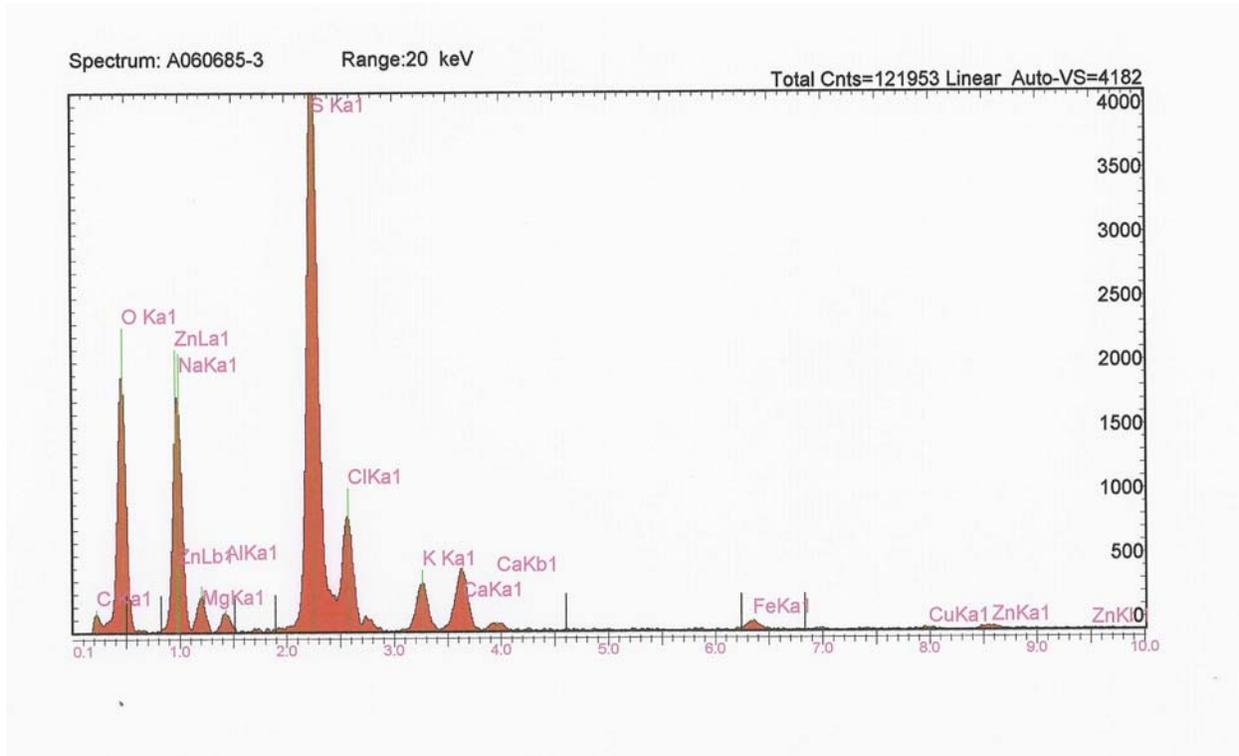
Figure A3. EDX spectrum of non-volatile residue from water extract of filter element E1.

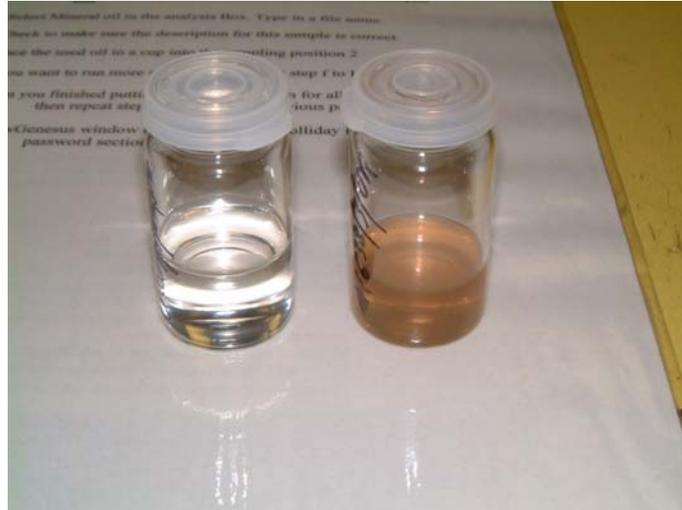
Fig 13: Fuel with suspended solids (right), Fuel after removal of solids by centrifugation (left)

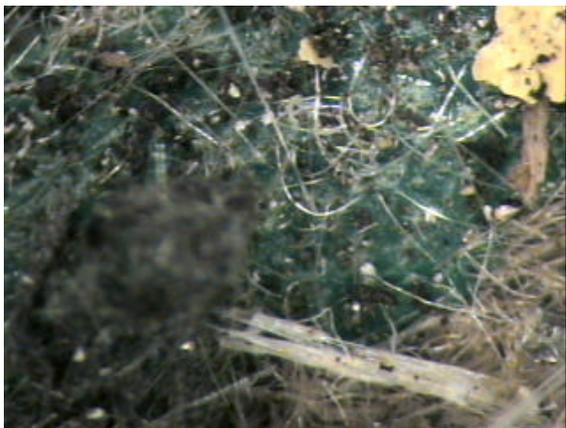
Figure 1: Debris from Cut Filter

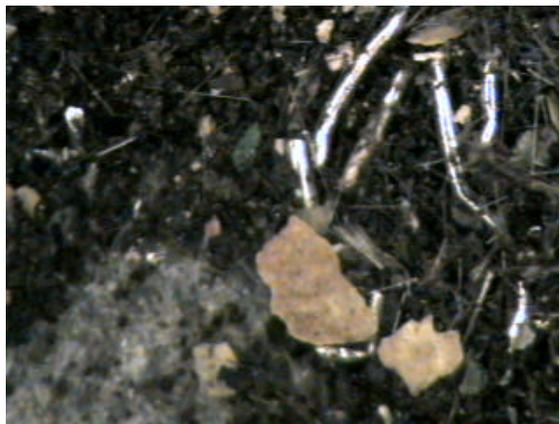
Figure 2: Debris from Cut Filter
