# GNSS & RWY safety

## EVAIR findings

Supporting  
European  
Aviation

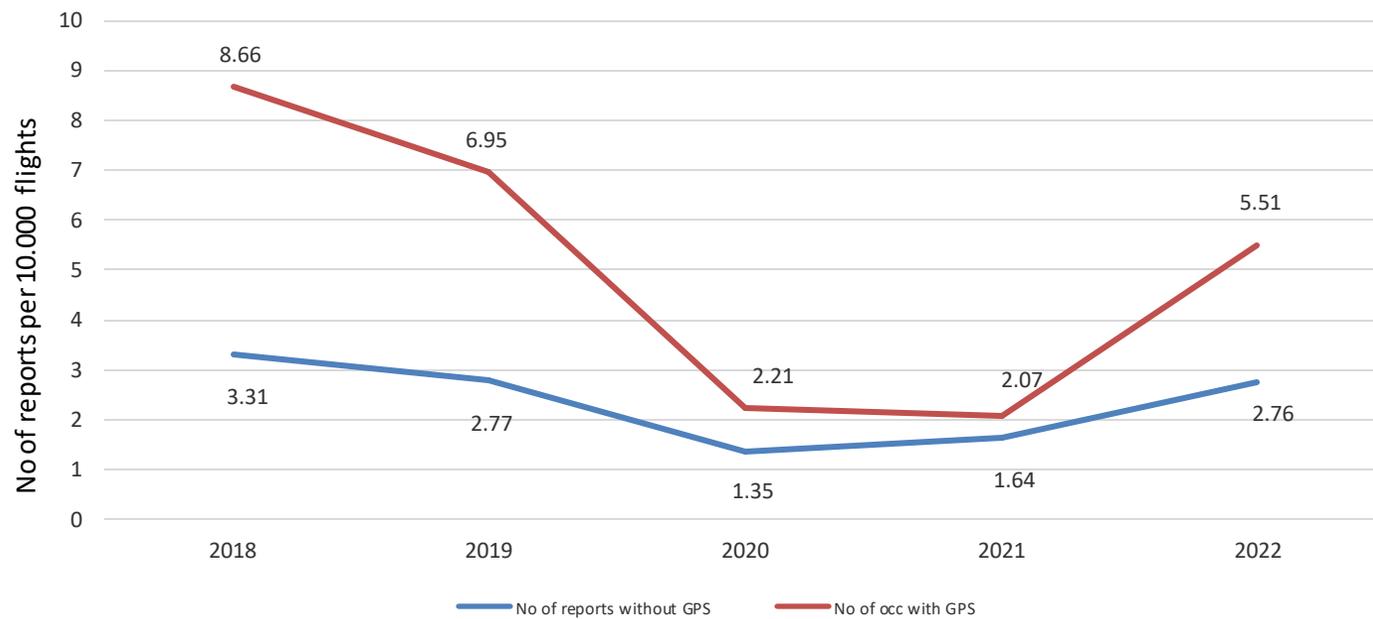
ATM trends with and without GPS  
2018-2022

**9139** AO/ANSPs reports

**11113** GPS Outage reports

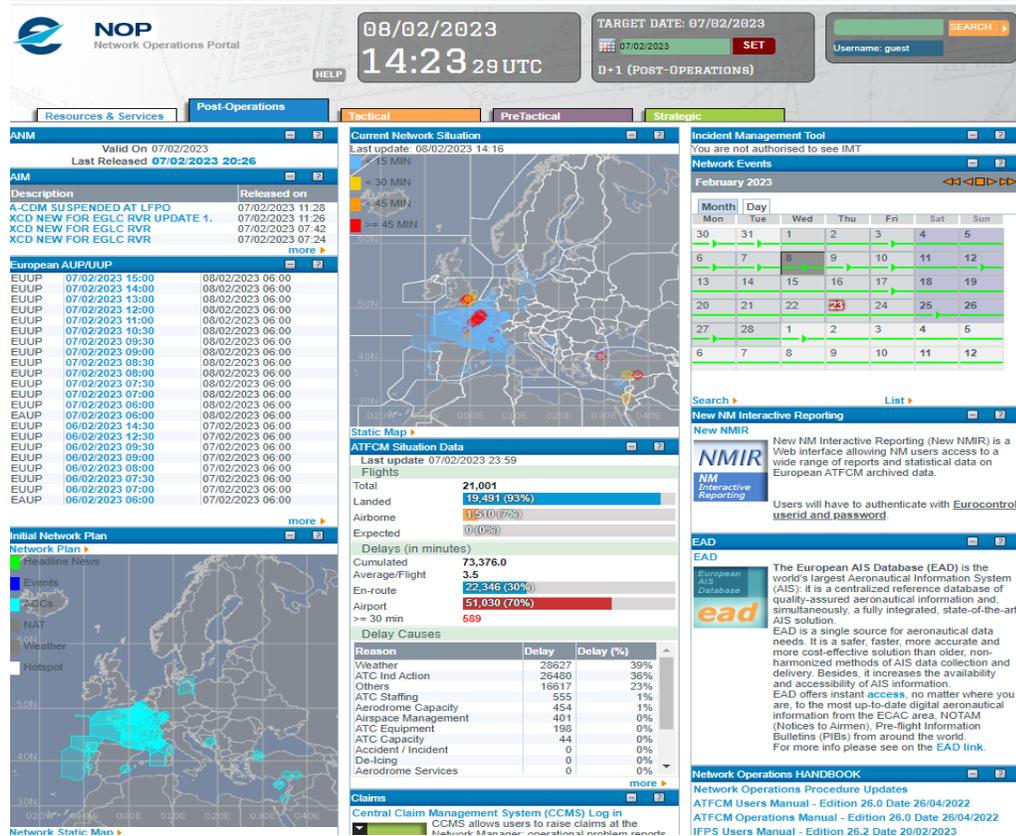
# AWARENESS - NM information communication

The screenshot shows the Network Operations Portal (NOP) interface. At the top, it displays the date 08/02/2023 and time 14:23 29 UTC. The interface is divided into several sections:

- Resources & Services**: Includes a search bar and user information (Username: guest).
- Post-Operations**: Contains a table of flight releases with columns for Description, Released on, and a 'more' link.
- Current Network Situation**: Features a map of Europe with various colored markers indicating network status.
- ATFCM Situation Data**: Provides a summary of flight statistics:

Total	21,001
Landed	19,491 (93%)
Airborne	1,510 (7%)
Expected	0 (0%)
- Delays (in minutes)**: Shows cumulative and average flight delays:

Cumulated	73,376.0
Average/Flight	3.5
En-route	22,346 (30%)
Airport	51,030 (70%)
>= 30 min	689
- Delay Causes**: A table detailing the reasons for delays:

Reason	Delay	Delay (%)
Weather	28627	39%
ATC Ind Action	28400	36%
Others	16617	23%
ATC Staffing	555	1%
Aerodrome Capacity	454	1%
Airspace Management	401	0%
ATC Equipment	198	0%
ATC Capacity	44	0%
Accident / Incident	0	0%
De-icing	0	0%
Aerodrome Services	0	0%
- Initial Network Plan**: Includes a map and a table of flight releases.

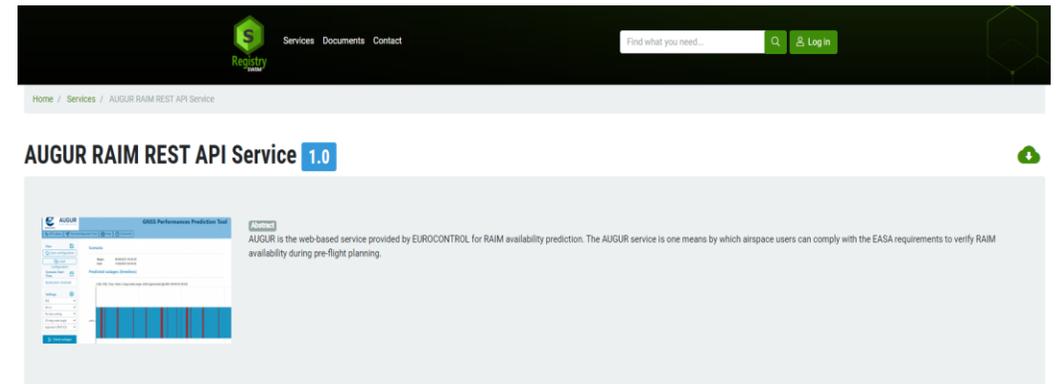
**AUGUR RAIM REST API Service 1.0**

The screenshot shows the AUGUR RAIM REST API Service interface. It includes a search bar, a 'Log in' button, and a table of flight releases. The table has columns for 'Flight' and 'Status'.

AUGUR is the web-based service provided by EUROCONTROL for RAIM availability prediction. The AUGUR service is one means by which airspace users can comply with the EASA requirements to verify RAIM availability during pre-flight planning.
